LYNG CHURCH

Fredericia, Denmark

Technical Specifications

Roof: 2,000 m² 15 t Double Standing Seam
RHEINZINK-prePATINA blue-grey

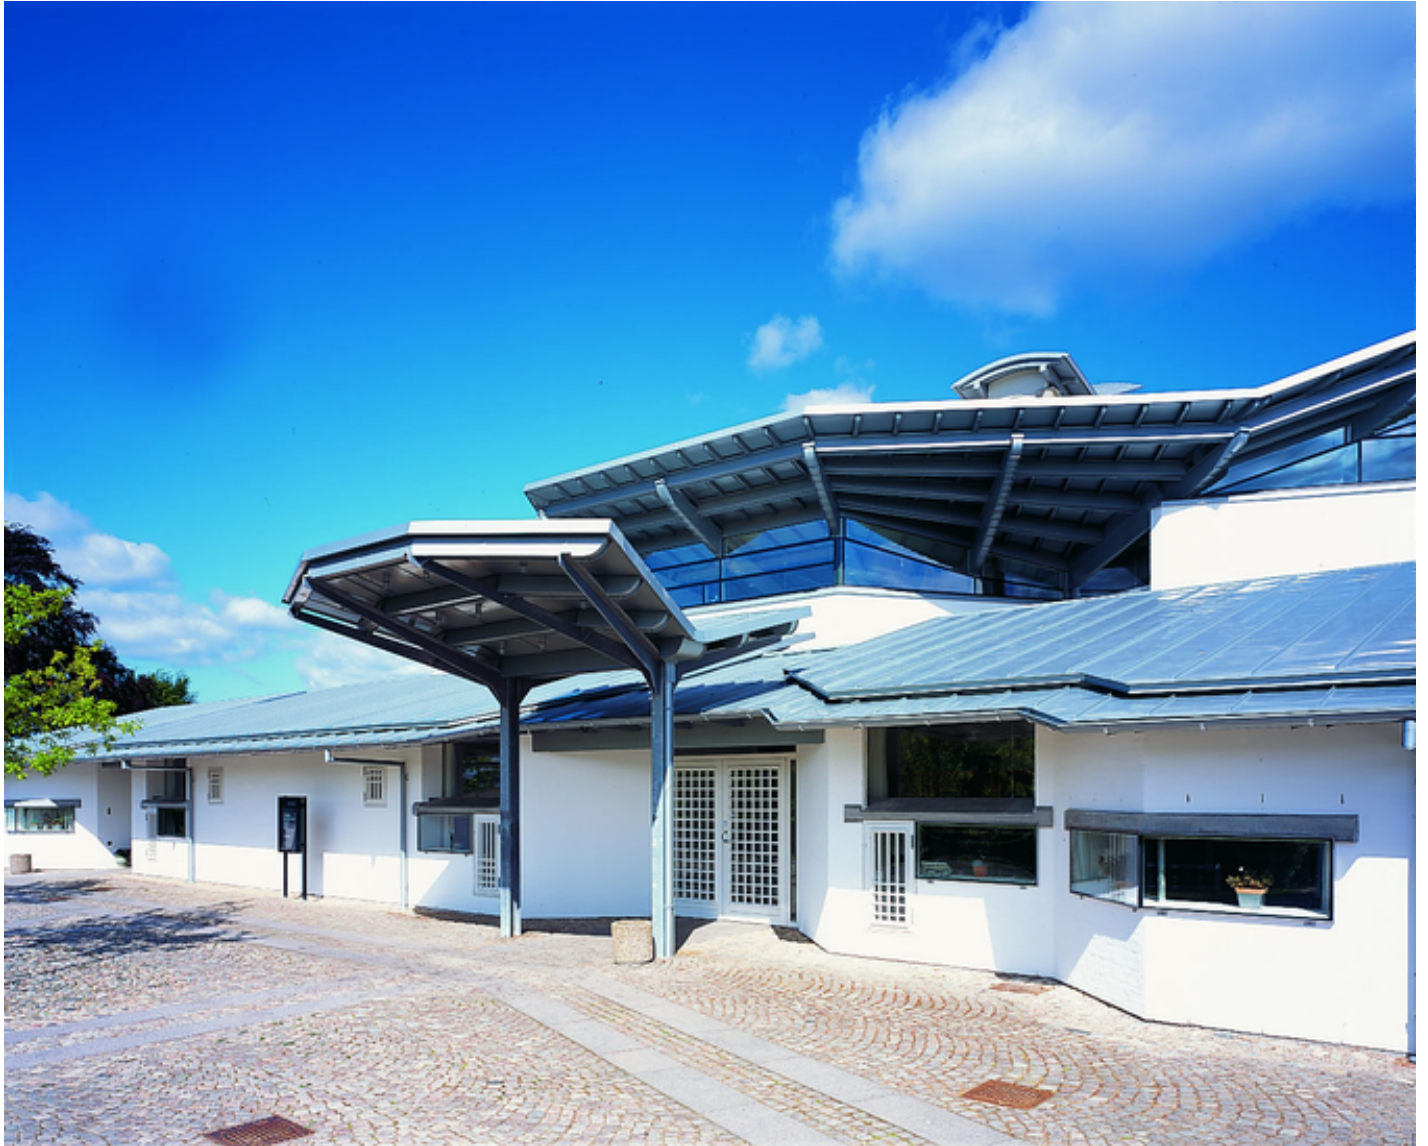
Some years ago, the roof of Lyng Church in the south of Denmark had to be restored. At that time the roofing - made of stainless steel, with defects in the joints and a very weather-exposed eaves construction with large glulam beams - took in water. As a result, the load-bearing structures in wood began to rot.

A new zinc cladding in the surface RHEINZINK prePATINA was mounted everywhere at an underlayer of 15 mm high, perforated zinc hat profiles due to extensive rot damage in roof ridges and roof edges. All rotten wood was replaced and painted before the zinc cladding was mounted. By mounting the perforated profiles, an 18 mm. ventilated cavity was ensured between the zinc cladding and the existing wooden structures.

To achieve an optimal airflow, the cladding on the back of all main girders, roof trusses and rafters is made of perforated zinc. The zinc overhang cladding is made with an air gap at all edges - also in perforated zinc. Perforation with a hole diameter of 3 mm. was chosen, as this hole size ensures that bees and other insects are not able to enter the ventilated cavities.
