# VACATION HOME GERMANY

Niederzissen, Germany

## **Roof renovation with RHEINZINK GRANUM basalte**

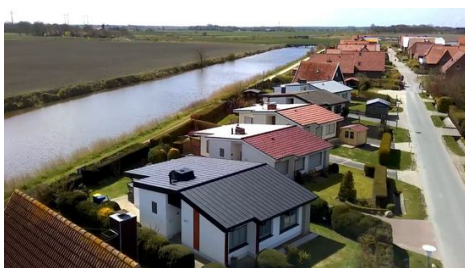
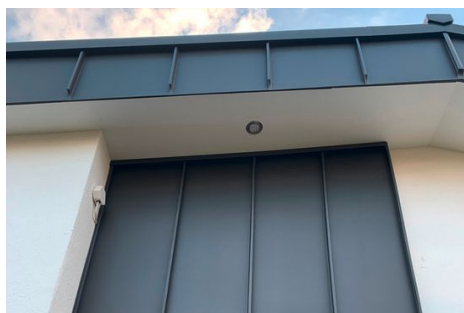
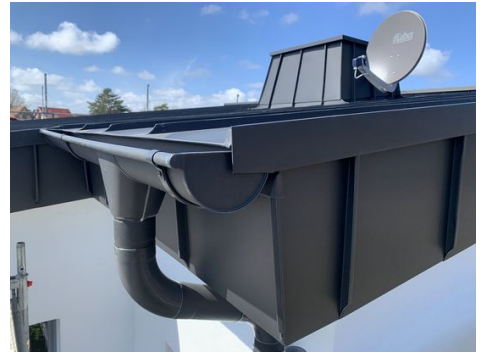
The holiday home of the Keuler family of roofers and plumbers was built in the early 1970s in the bungalow style and a roof covering typical of the time with the Berlin wave. Minor storm damage, defective gutters and the first leaks now required renewal. Besides, a roofer's house should look decent at all times, as Stefan Keuler emphasises. Of course, this also applies when, as in this case, there are about 450 km between the holiday home and the company's headquarters in Niederzissen, Rhineland-Palatinate. It was there in 1961 that Stefan Keuler's grandfather founded the company that today operates as Lehmann GmbH Meisterbetrieb für Bedachung und Klempnerei. It was precisely because of this dual range of services and because of the low pitch of the roof that it made sense to re-roof the holiday home as a metal roof.
